SUMCO

INDIANAPOLIS, IN

CASE STUDY

EMCOR Services Shambaugh

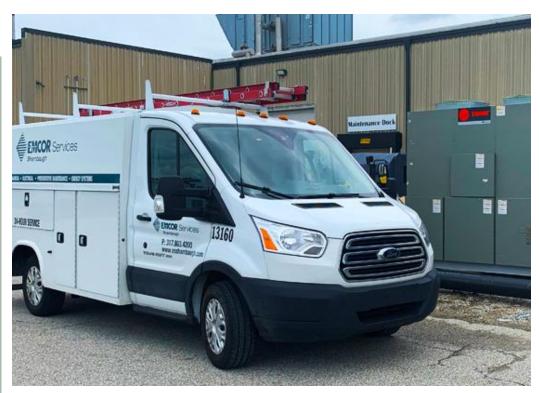
We demolished and removed four make-up air (MUA) units, and replaced them with MUA units on SUMCO's structural steel roof. We then installed a high-efficiency chiller, and reconnected all electrical feeds, gas feed, and chilled water lines. The project was completed during normal business hours, on schedule, and within budget.

- Four 100-ton MUA units with chilled water coils
- Duct connections to existing roof openings
- A 400-ton air-cooled dual-power chiller with electrical and chilled water line connections
- Factory startup of newly-installed equipment and warranty
- A custom preventive maintenance program
